ODI RESUME

Investigation: EA 02-021
Prompted By: PE01-042
Date Opened: 09/06/2002 Date Closed: 11/06/2003
Principal Investigator: TOM BOWMAN
Subject: FRONT SUSPENSION U-BOLTS LOOSEN OR BREAK

Closing Report – EA02-021

Alleged Front Suspension U-bolt Failures (fracture, torque loss, stretching, or continuous loosening) in 1998 – 2003 model year (*) Volvo Truck North America (VTNA) VN Model Highway Tractors

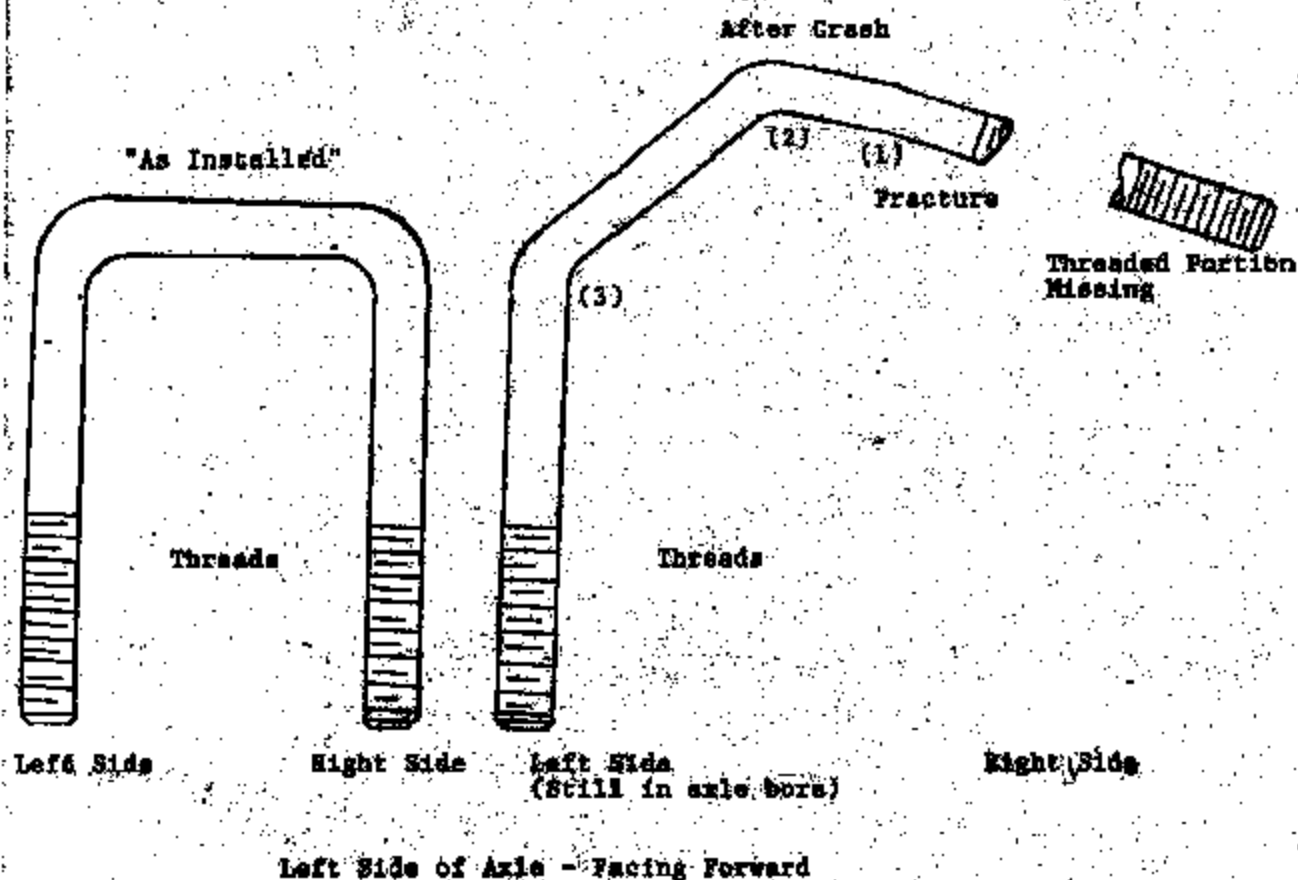
The right-side bore for the fractured U-bolt is "open" and the portion of the U-bolt that had been installed through this bore had been broken off within a thread or two of the run-out into the U-bolt shank. The fractured piece of the U-bolt was missing and the right hand side of this U-bolt had been bent at three locations:

- (1) a slight bend approximately midway on the shank (unthreaded portion) of the right side of the U-bolt.
- (2) The right angle bend on the fractured leg has been bent open from the original 90 degree right angle bend to approximately 120 degrees.
- (3) The right axle bend on the unfractured leg of the U-bolt has been bent open from the original 90 degree right angle bend to approximately 150 degrees.

ODI believes that the damage to this U-bolt was most likely caused by the following event sequence:

- (A) A significant lateral force toward the right side of the vehicle caused the small bend [identified as (1) above] in the right side leg of the U-bolt
- (B) The lateral force was so significant that it exceeded the ultimate strength of the U-bolt which then fractured through the right leg. The right leg and retaining nut must have been in place during this loading to provide a reaction force for this significant tensile force. If the U-bolt leg or retaining nut were not in place, it is doubtful that the U-bolt would have been anchored strongly enough to permit a bend to occur at this mid-point in the U-bolt's right side leg.
